Maranoa Regional Council

Roma Stage 2 Flood Mitigation Project Operation and Maintenance Manual

April 2016

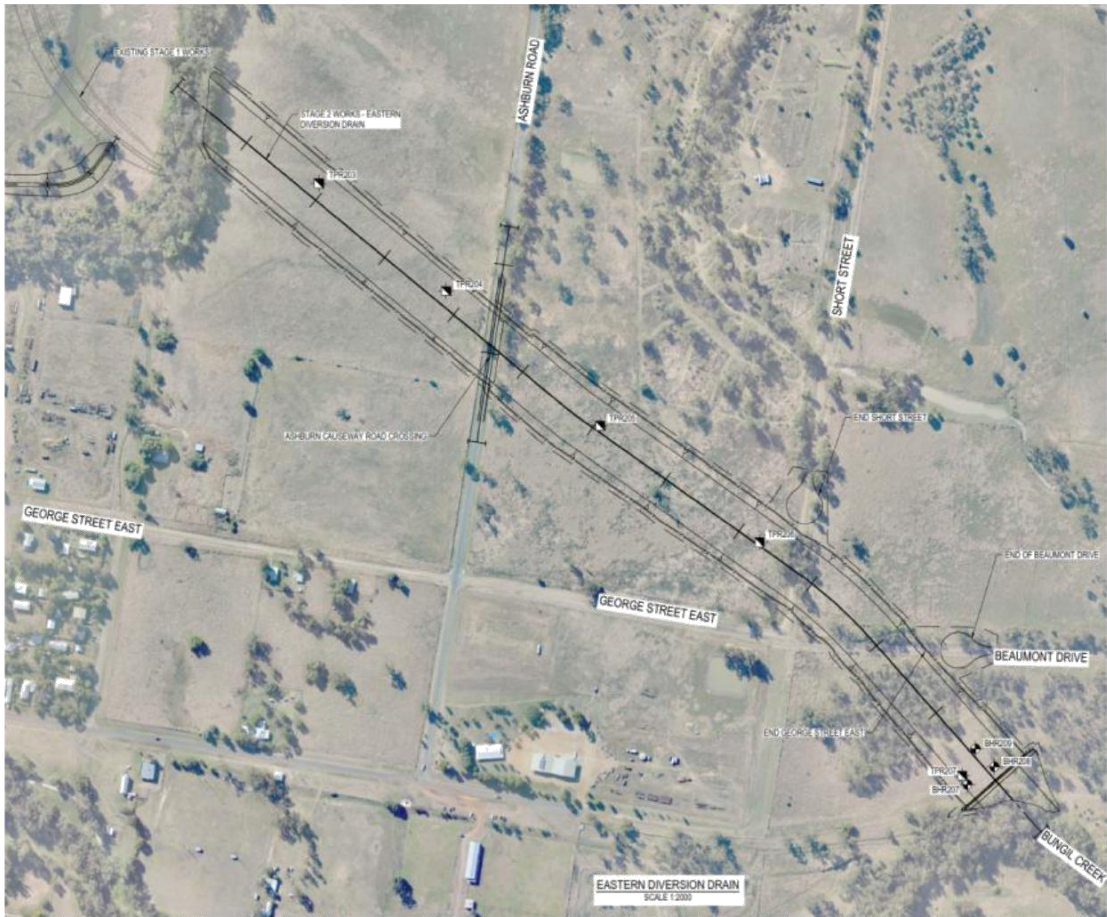
Figure 1-1 Eastern Diversion Drain Plan and Location

The diversion drain contains a central 1 m wide v-drain to provide for drainage of small rainfall events. A causeway is provided along Ashburn Road with an integral 1 m drop to control erosion energy. A 3 m high gabion drop structure within the stilling basin at the southern end of the drain has been provided to dissipate energy and control erosion within the erodible sands at the interface with Bungil Creek.

The channel is grass lined throughout the length, with rock protection provided at critical locations including the drain entrance at Bungil Creek, the downstream area of the causeway, the 3.0 m high gabion drop structure and the northeast bank of the stilling basin at the downstream interface with Bungil Creek.

A plan and location map of the Eastern Diversion Drain is shown below in Figure 1-1.

The Eastern Diversion Drain requires manual operation of flood boom gates at the entrances of the Ashburn Road causeway crossing.

The diversion drain contains a causeway that will require closing during a flood event to prevent access to the public and subsequently reduce the risk of flood related incidents. Boom gates installed at each causeway entrance shall be closed before the flood level reaches the invert of the causeway, preventing the crossing of traffic.

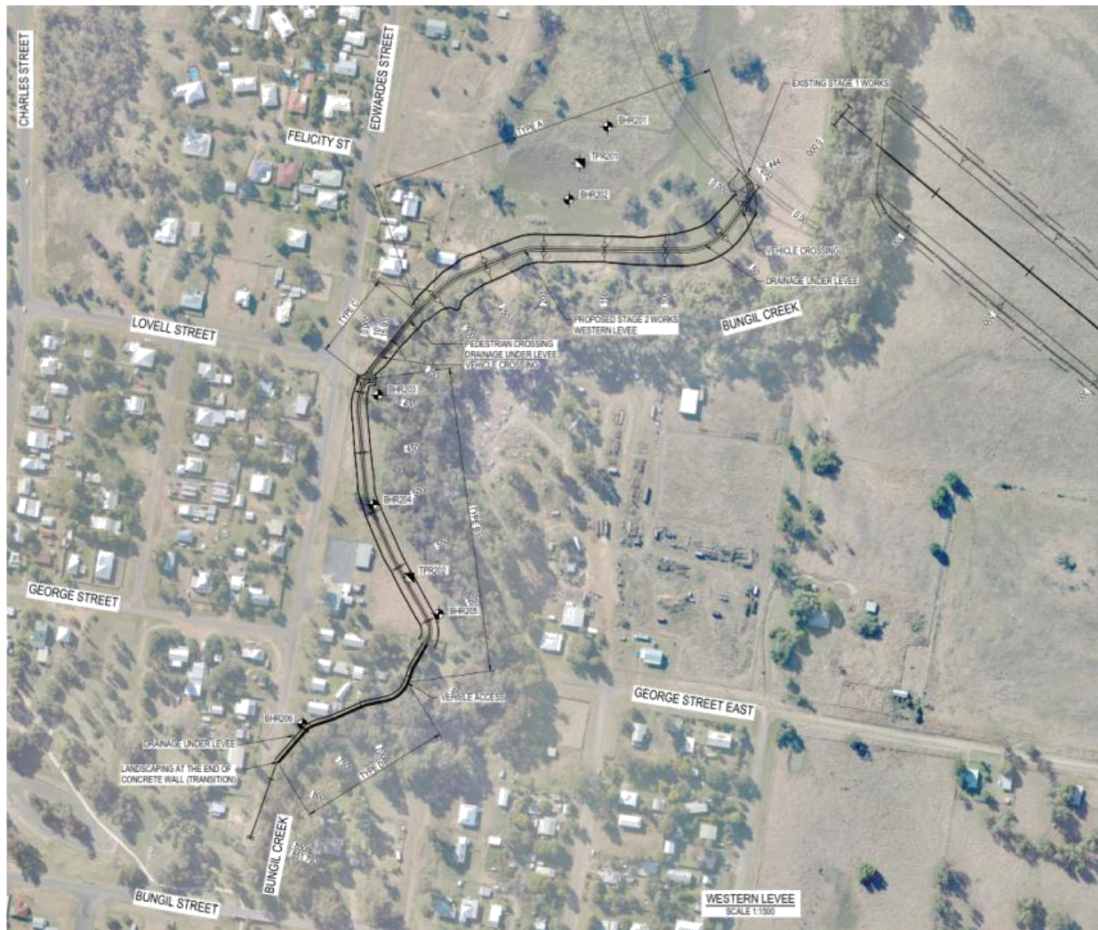
Figure 1-2 Western Levee Plan and Location

The crest height for the levee is based on the 2012 Design Flood Event (DFE) and includes a 0.8 m freeboard.

A plan and location map of the Western Levee is shown below in Figure 1-2.
